MTMC REPORT OA 78-7b-8 ✓

**ANALYSIS
OF MTMC PARTICIPATION
IN THE
REFORGER 79 EXERCISE**

MAY 1979

**MILITARY TRAFFIC MANAGEMENT COMMAND
TRANSPORTATION ENGINEERING AGENCY
NEWPORT NEWS, VIRGINIA 23606**

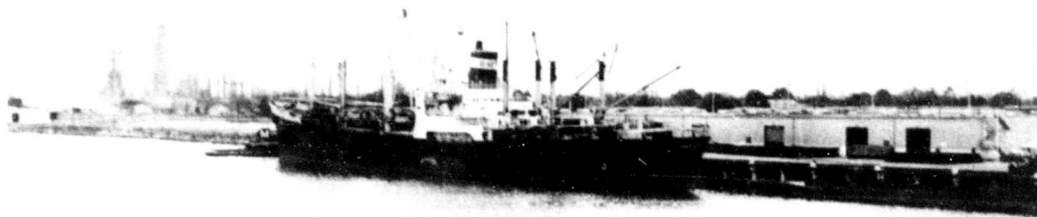
Figure 3-1. SS American Corsair, breakbulk ship.

a. The characteristics of the ships used to transport REFORGER 79 equipment are presented in table 3-1. The ships are pictorially displayed in figures 3-1 through 3-5.

has four decks, one large loading hatch, and two 45-LTON deck-mounted cranes. The SS American Corsair, a Challenger I class vessel and part of the MSC charter fleet, is a six-hatch breakbulk vessel.

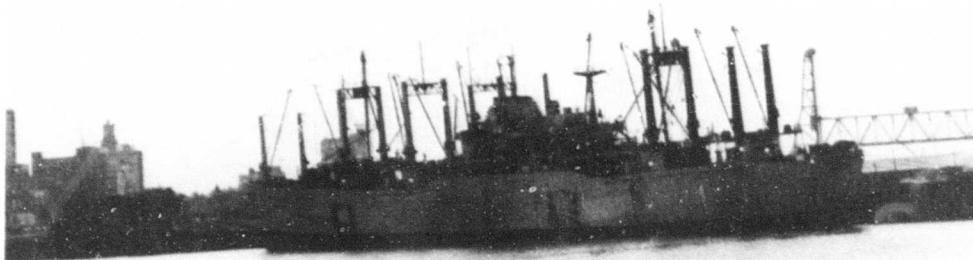
Figure 3-3. USNS Comet, RORO ship.

b. The three nominated RORO ships, the GTS Callaghan, USNS Meteor, and USNS Comet have stern- and side-loading ramps, internal ramps for roll-on deck loading, and cargo hatches for lift-on, lift-off operations. The SS Maine was activated from the Ready Reserve Force (RRF) of the National Defense Reserve Fleet (NDRF) for REFORGER 79. It is a converted T2 tanker, now considered a breakbulk/Seatrain type of ship, specifically designed to transport vehicles and outsize cargo. It

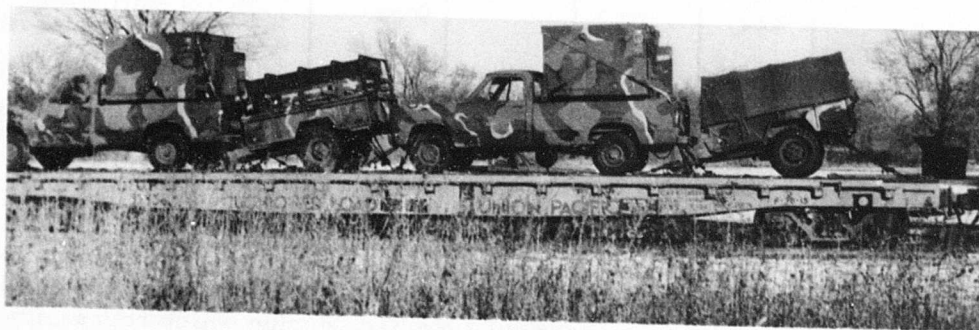
Figure 4-2. Optimum use of space made by dropping trailer tongues under prime movers.

(3) Prime movers and trailers were loaded together whenever possible. To make optimum use of railcar space, truck cargo beds and trailers were loaded with shelters or other equipment, and trailer tongues were dropped under prime movers (fig 4-2). Wheeled vehicles were loaded circus fashion (a procedure whereby vehicles line up single file and traverse the length of the train, from car to car, stopping as the train fills up) at Camp Funston sites 4, 5, and 8.

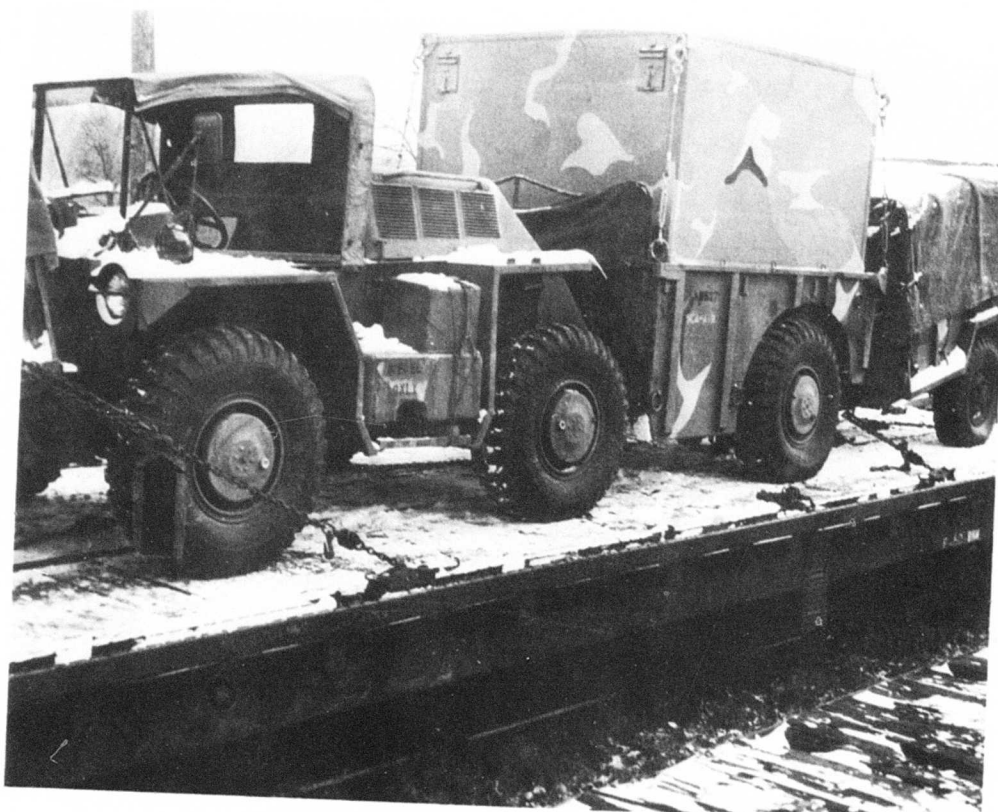
Figure 4-3. Chain tiedown hooks were not wired shut at Fort Riley.

(4) The Union Pacific Railway inspector did not require chain tiedown hooks to be wired shut, as required by AAR open-top railcar loading rules (fig 4-3).

f. Railcar chain-tiedown hook openings be wired to prevent them from coming loose if chains become slack during shipment.

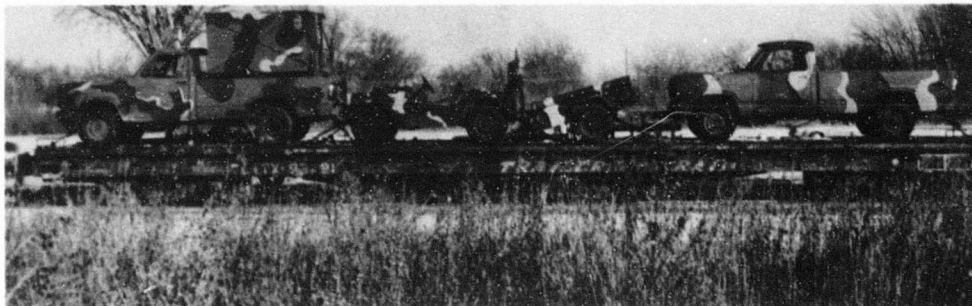
Figure 4-4. Vehicles not properly spaced on railcars at Fort Riley.

(5) Some vehicles were loaded without adequate spacing between vehicles on railcars. Although MTMC recommended 12 to 18 inches between vehicles, in some instances vehicles were loaded with only 3 to 4 inches (fig 4-4) separating them.

g. A minimum of 12-inch spacing be maintained between vehicles loaded on flatcars (with the exception of M60A1 tanks) to allow adequate room for securement devices and to preclude damage caused by vehicles rubbing together during railcar movement.

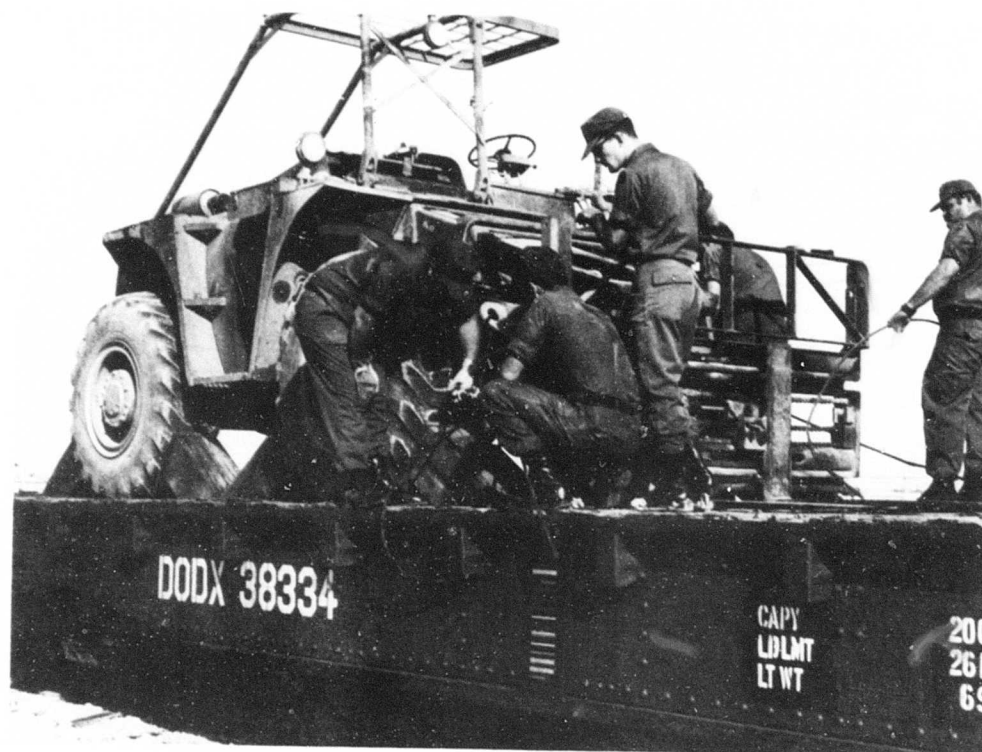
Figure 4-7. Rail outloading training being conducted at Fort Hood by MTMC.

(1) MTMC representatives conducted rail outloading training in October 1978. Training consisted of both classroom instruction and a practical exercise in loading and securing representative REFORGER equipment onto DODX flatcars (fig 4-7). More than 60 personnel attended and enthusiastically received the training. In particular, an M60 test tie-down procedure using two wire-rope turnbuckle combinations at each end of a tank, plus metal chocks at each end of the tracks, was demonstrated. (This test tiedown method was to be used in lieu of the standard method of

cable end tiedowns, wooden track chocks, H-frames, and bogey wheel chocks, as used during REFORGER 78.) In addition to this training by MTMC, the Directorate of Facilities Engineering (DFE), Packing and Crating Shop, conducted rail loading classes on a continuing basis. These classes provided training for 120 to 300 personnel per week.

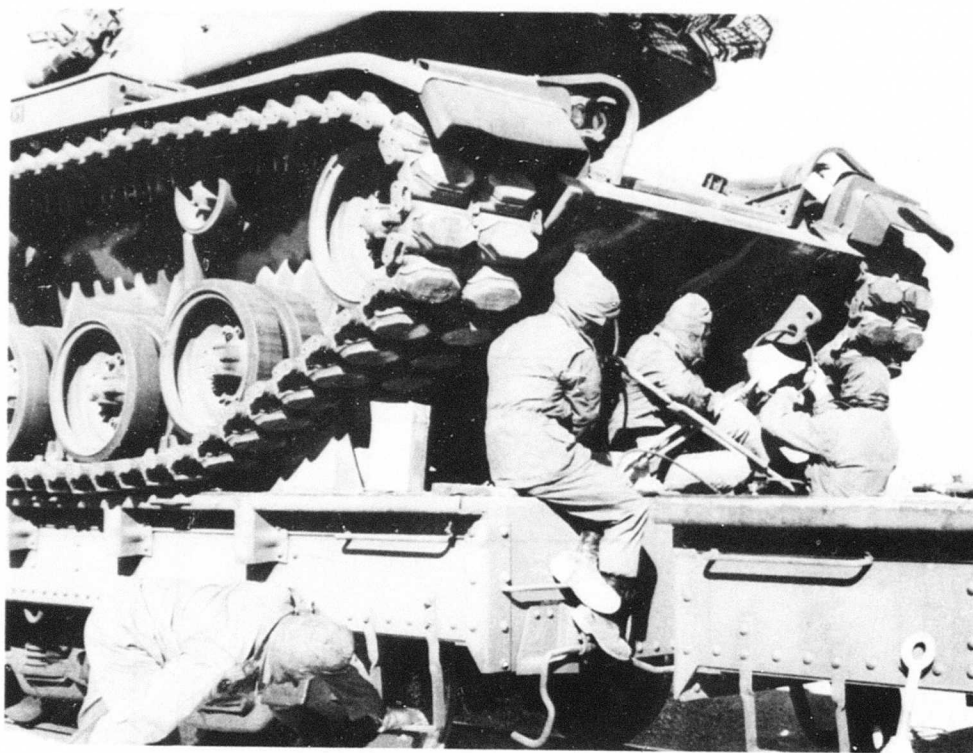
Figure 4-8. Unit personnel securing M60 tanks, Fort Hood, Texas.

(1) Rail outloading operations commenced 4 December 1978, with the establishment of a rail operations center at the railhead, and were completed 14 December 1978. The entire outloading operation took place at the railhead, with equipment loaded and secured by unit loading teams (fig 4-8). Table 4-5 summarizes the rail outloading operation.

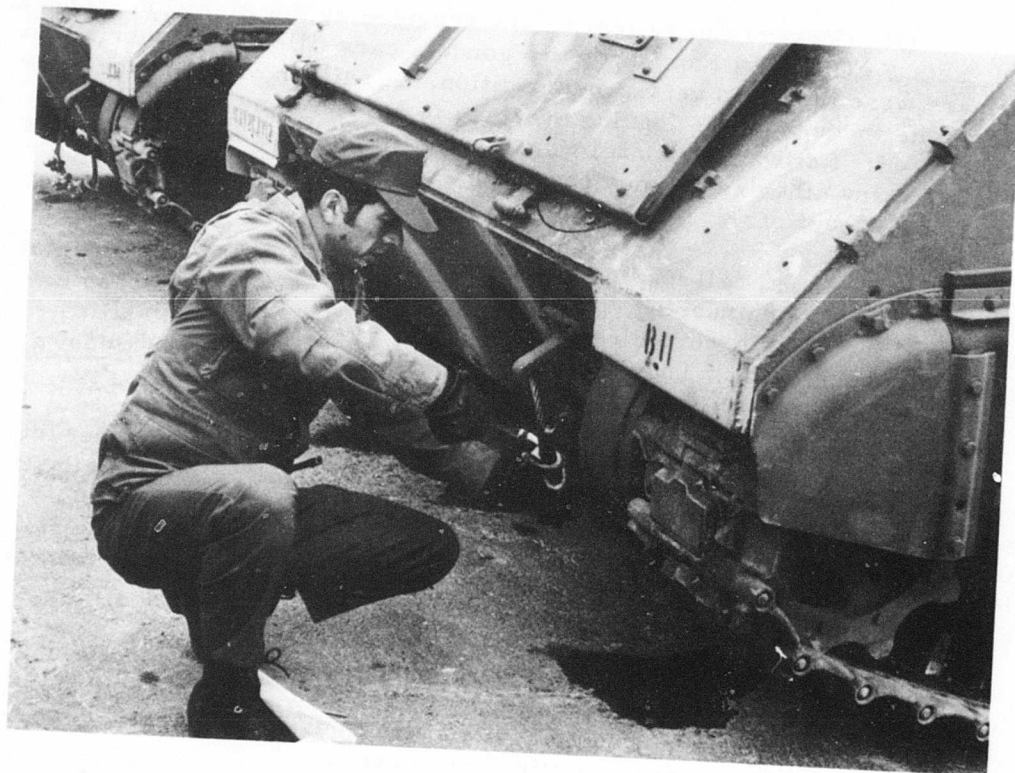
Figure 4-9. Wire rope loops were affixed to APCs in unit motor pools.

(10) Deploying units installed 5/8-inch wire-rope loops at M113-series tracked vehicle towing and tiedown provisions in lieu of the BILI (basic issue list items) towing, or T-shackles, or the transportability guidance technical manual (TGTM) specified shackles (clevis-assy, suspension, bolt-and-nut-type) (fig 4-9). While not in accordance with TM 55-2200-001-12, or AAR procedures, rail inspectors approved these wire-rope loops for use with railcar chain tiedowns. No en route cargo damage resulted from this method; however, these loops later proved incompatible with shipboard peck-and-hale lashing equipment. It is recommended that, in the future, deploying units comply with TGTM requirements and install specified shackles on all vehicles being shipped by rail or sea.

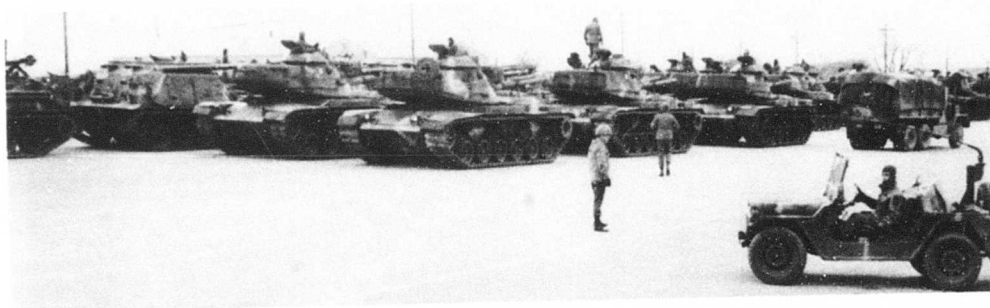
Figure 4-10. To facilitate rail loading, drivers remained with their vehicles until after they were rail-loaded.

respective unit motor pools, were so thorough that even vehicle floorboards were removed. After a vehicle received its customs inspection, it was sealed by customs personnel, and any person subsequently entering the vehicle was first searched. This search procedure caused some delay in loading vehicles onto train 1; however, this problem was alleviated by eliminating the staging of vehicles at the rail loading site. Drivers never dismounted from vehicles from the time they departed the motor pools until the vehicles were loaded on railcars of trains 2 through 5 (fig 4-10).

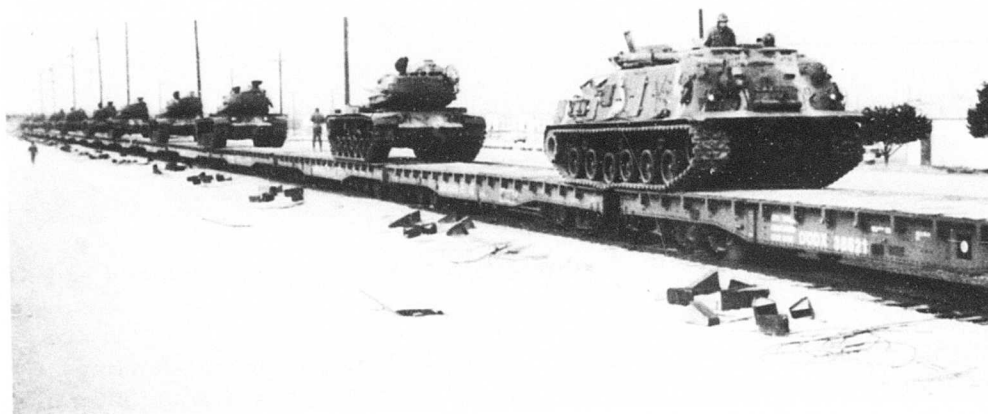
Figure 4-11. Circus-style rail loading of M88's and tanks.

(12) M60s, M88s, and other heavy tracked vehicles were driven onto railcars circus fashion without the use of spanners between railcars (fig 4-11).

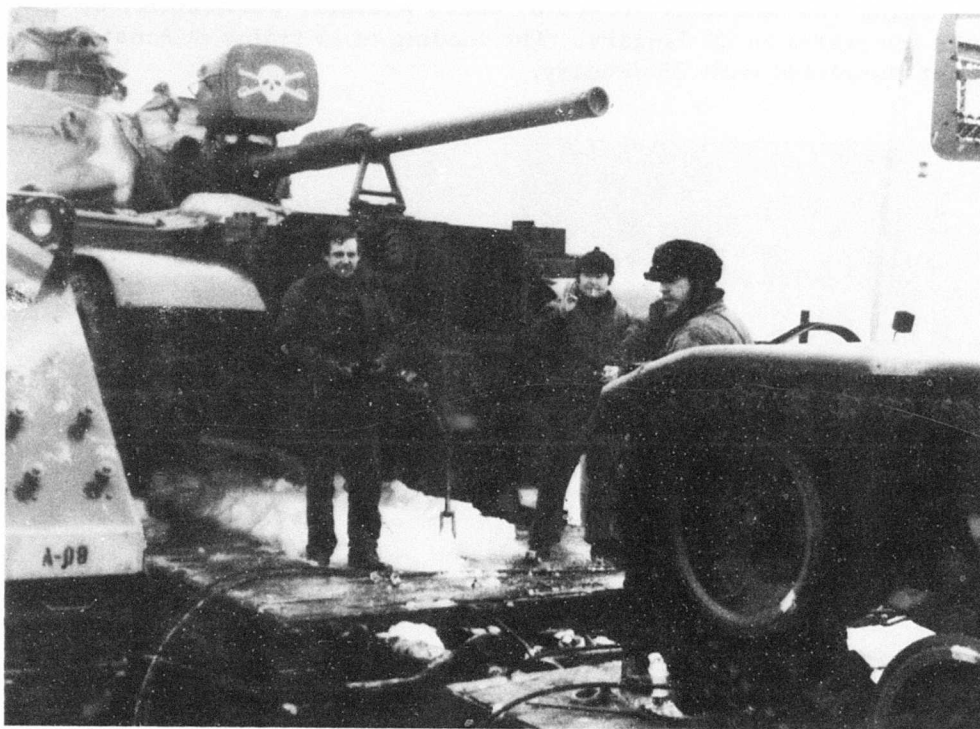
Figure 7-6. Lashing and blocking railcars.

Rather than lift these tractor-trailers onto railcars and create similar problems during rail unloading, 12 vehicles were convoyed, on 25 January, to Zolder, Belgium, to link up with the last convoy from Haasdonk, Belgium, to Boeblingen, Germany. Although many of the railcars were lashed and blocked in the port area (fig 7-6) to alleviate congestion on the quay, some were moved to railcar holding areas to complete securing.

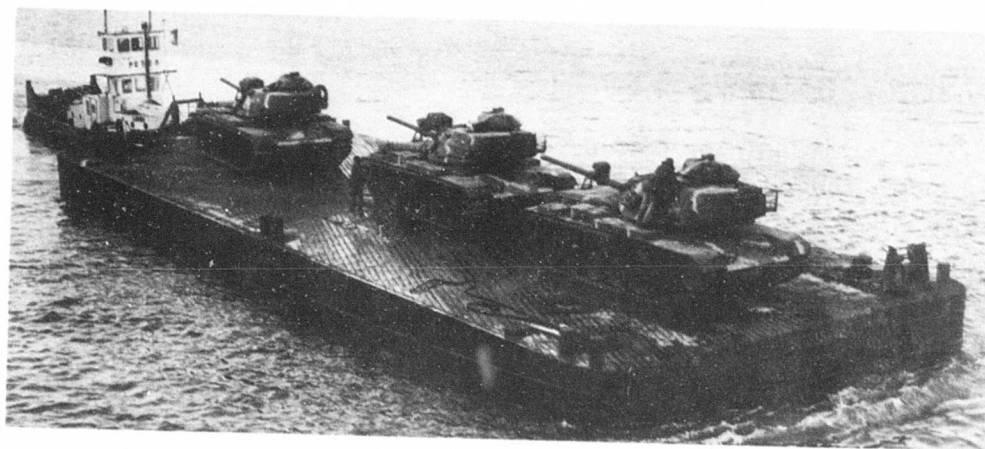
Figure 7-11. A pushbarge shuttles tanks from the SS Maine to the quay.

f. The SS Maine berthed at 6e Havendok (fig 7-9) 15 January at 2326 hours. Prechecking was done on the afternoon of 16 January, and discharge began at 0600 hours the next day. Both of the ship's cranes and a shore crane were used to discharge cargo. Forty-two M50A1 tanks and M88 tank retrievers were discharged with a barge derrick crane, since the shore crane had insufficient capacity to lift tanks. (Ship's cranes working in tandem could have unloaded the tanks; however, this method was not used, since delays were anticipated should one of the ship's cranes become inoperable.) The barge derrick crane was moored to the offshore side of the vessel (fig 7-10). Since the crane had insufficient reach to extend across the vessel to the quay, the tanks were lifted onto a pushbarge. The pushbarge then moved the tanks, three at a time, to the quay where they were driven off (fig 7-11). Discharge was completed at 1635 hours, 19 January.

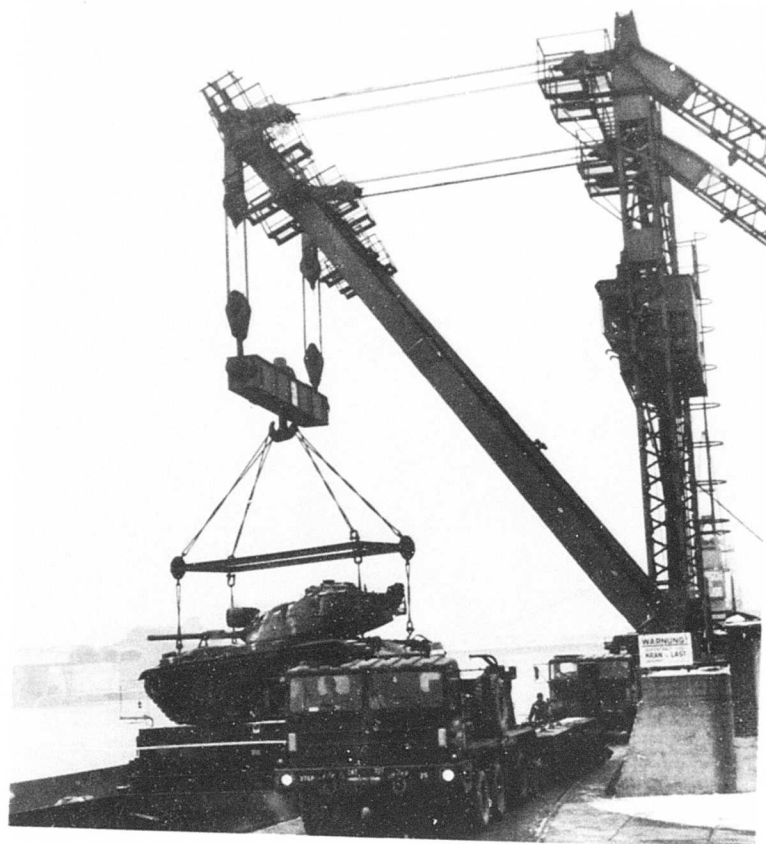
Figure 9-3. Mannheim Port Goliath crane.

a. Under the supervision of MTMC Rhine River Terminal, REFORGER cargo was loaded into nine barges: six in Karlsruhe, at Kalag Karlsruhe (fig 9-2), and three in Mannheim at the Goliath Crane location (fig 9-3).

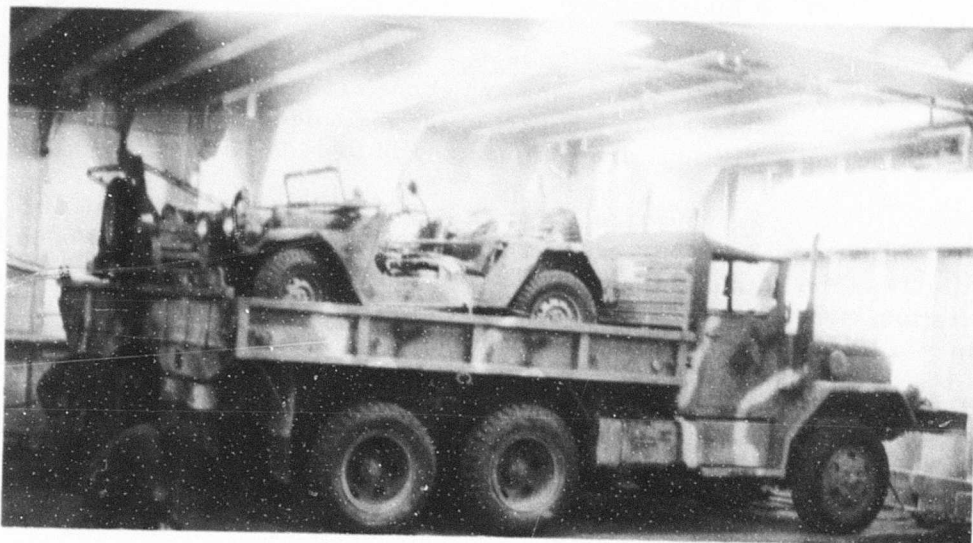
Figure 9-15. To insure adequate space aboard USNS Meteor, vehicles were consolidated.

4. Since the USNS Meteor was the final ship to be loaded, equipment was consolidated at the port to insure that loading space aboard the ship would accommodate all available cargo (fig 9-15). Cargo consolidation operations proved difficult as most cargo beds contained quantities of unsecured cargo.

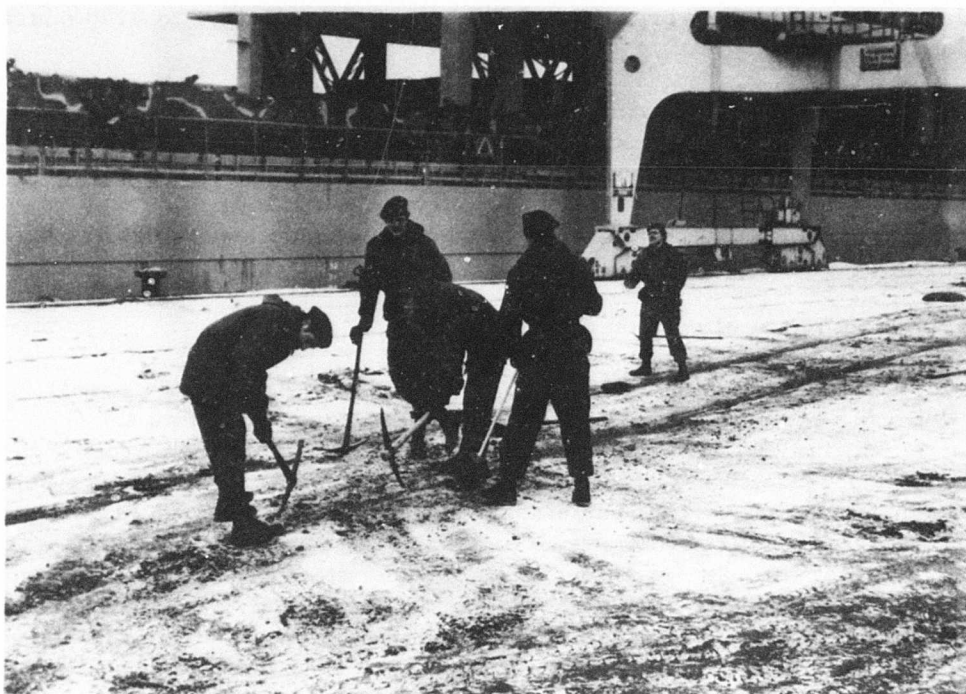
Figure 13-2. Belgian Army personnel clearing ice from rail tracks in port area.

c. Rail outloading was slowed because arriving railcars had to be cleared of accumulated snow (fig 13-2). Vehicles moving up rail ramps lost traction because their wheels spun through the sand. Deadlined vehicles had to be towed onto railcars; this procedure consumed at least 1 hour of effort per deadlined vehicle.
